DANVERS RIVER BASIN  
BEVERLY, MASSACHUSETTS

SHOE POND DAM  
MA 00183

**PHASE I INSPECTION REPORT  
NATIONAL DAM INSPECTION PROGRAM**

SEPTEMBER 1979

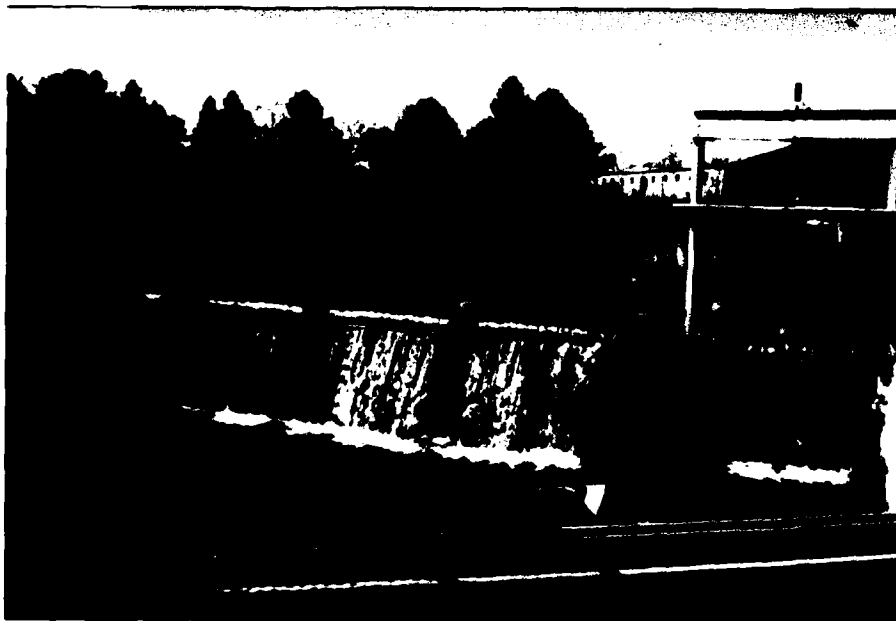
**NO. 2 SHARP CRESTED WEIR AND LOW LEVEL GATE**

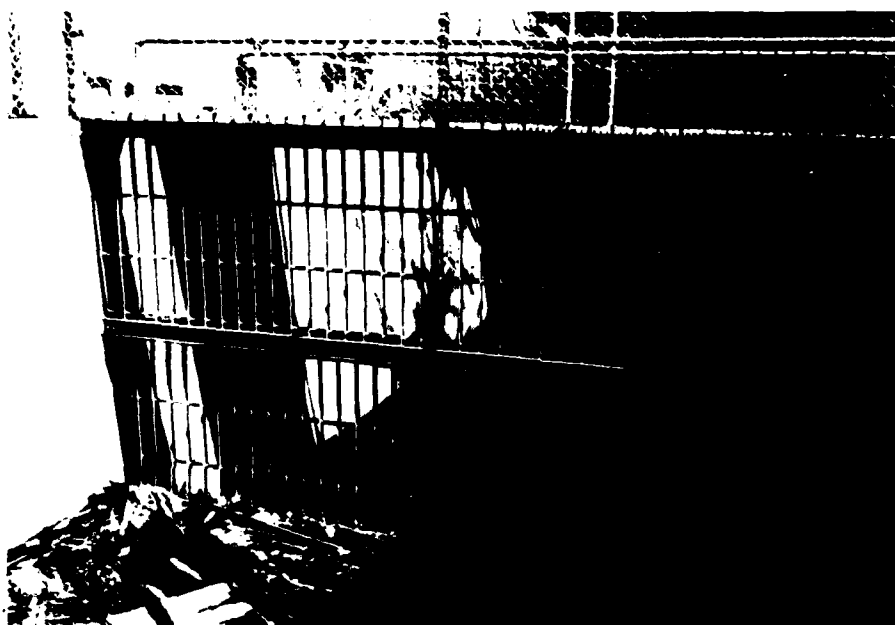
The concrete of the chute is spalled and cracked in places, and debris has piled up 2 to 3 feet deep at the trash rack. Trees and bushes are growing along the west side of the chute.

**NO. 8 TRASH RACK AND CHUTE**
